TOPSOIL MOVEMENT & CONSTRUCTION RECORD

PHASE I

LILA CANYON MINE

December 2008-February 2009

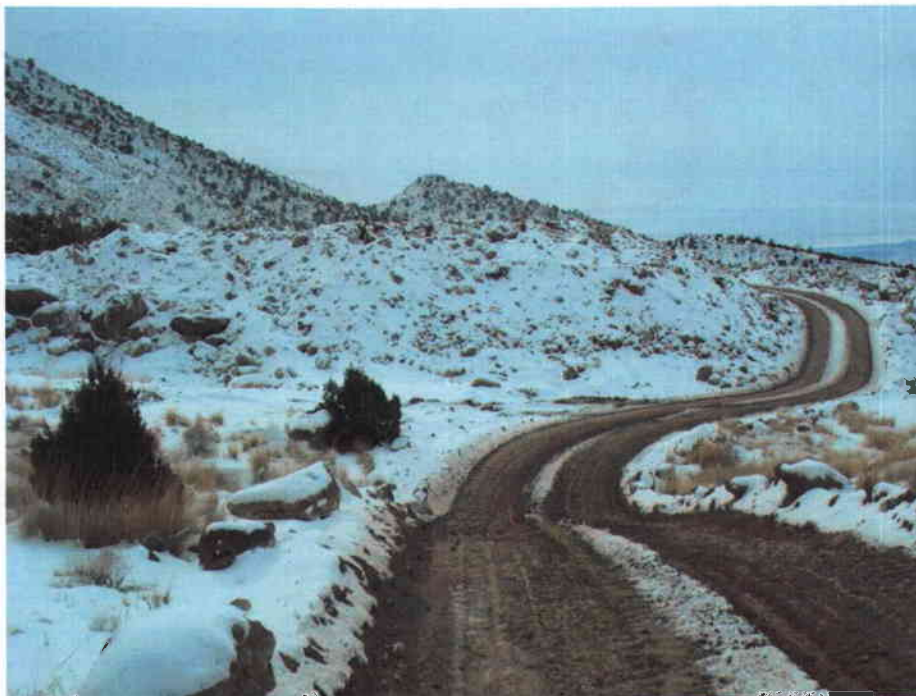
LOOKING SOUTH TOWARDS TOPSOIL STORAGE AREA

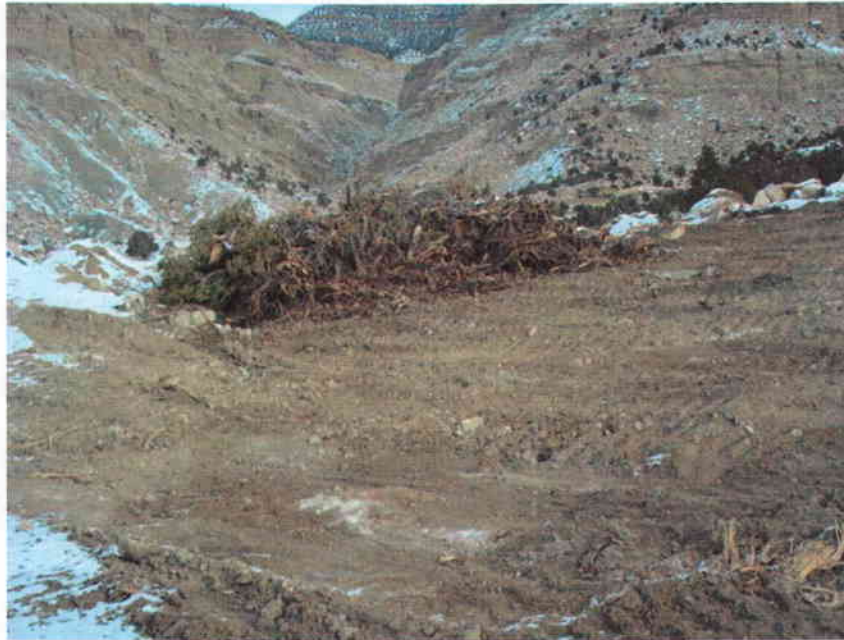
MATERIAL REMOVED FROM TOPSOIL STORAGE SITE

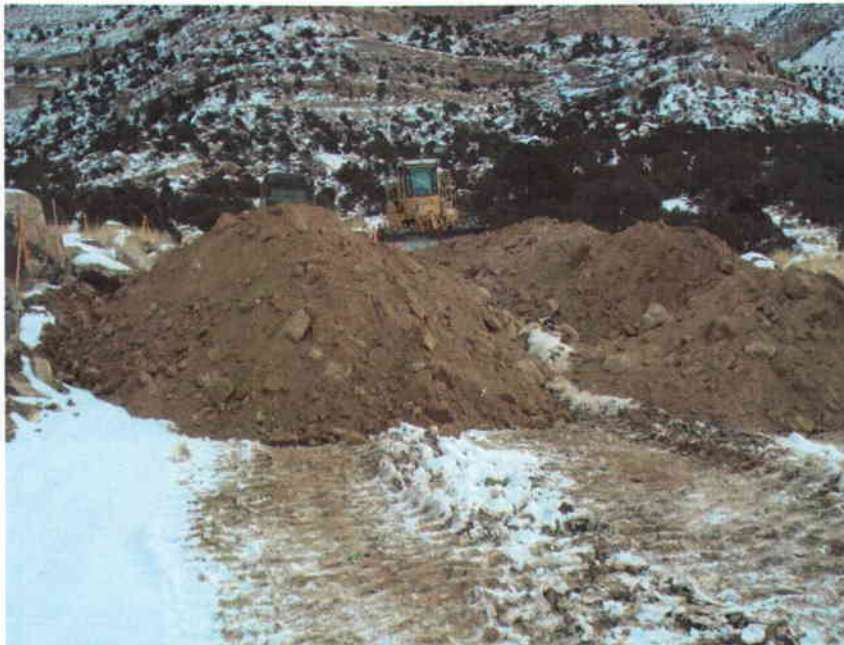
**PORTAL ACCESS ROAD TOPSOIL NORTH OF COAL STOCKPILE, PHOTO
TAKEN LOOKING EAST**

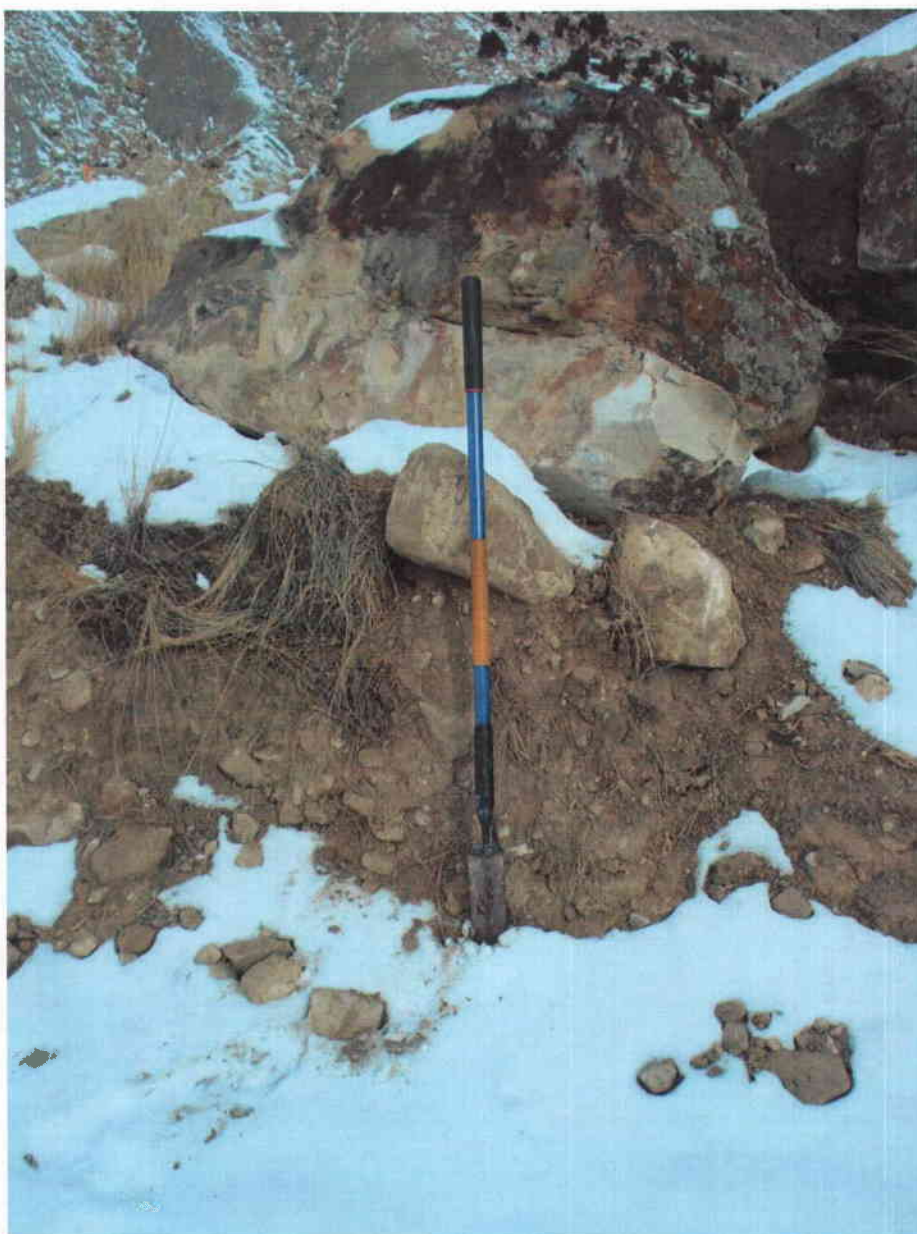
**SOIL PROFILE ON PORTAL ACCESS ROAD LOOKING NORTH, TAKEN
ADJACENT TO PRIOR PHOTOGRAPH**

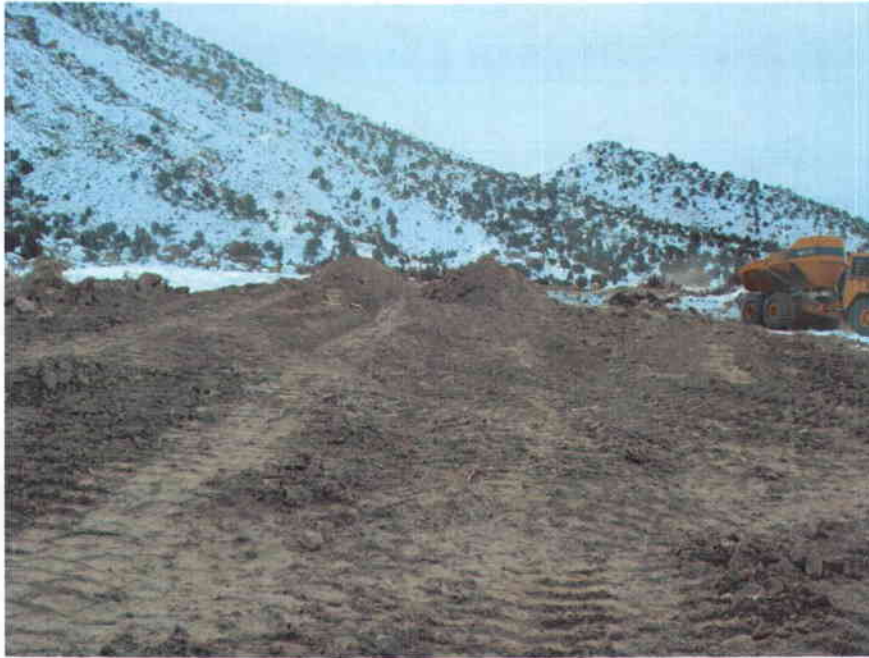
**TOPSOIL REMOVAL SOUTH END OF EMPLOYEE PARKING LOT
LOOKING SOUTH EAST**

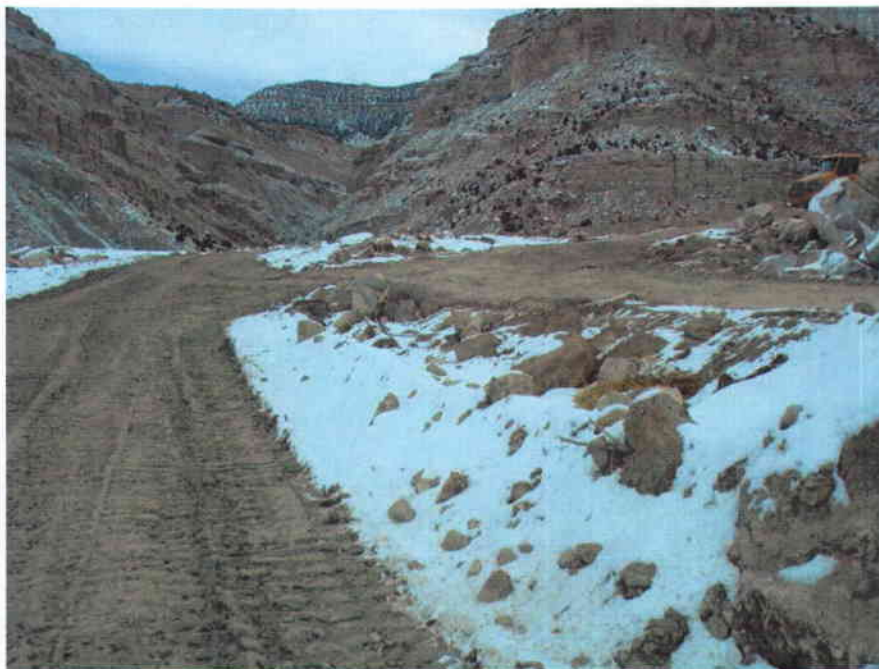
SOUTH OF LOADOUT STATION LOOKING NORTH

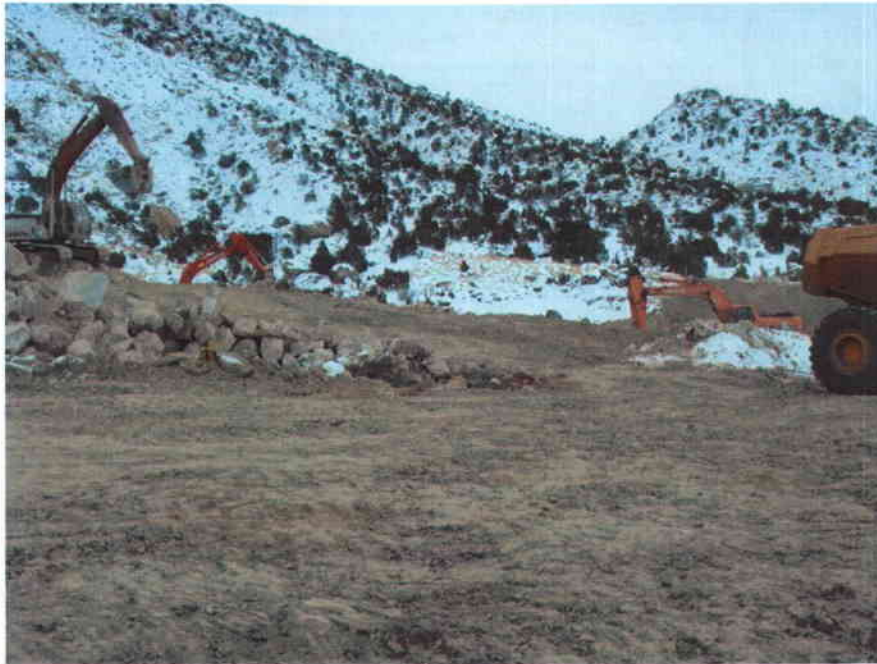
SOUTH OF LOADOUT STATION LOOKING SOUTH

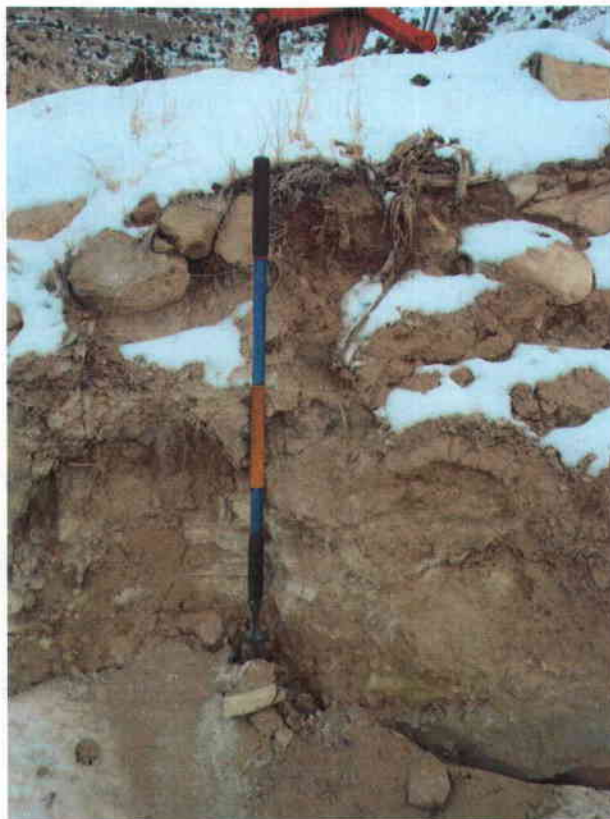
SOIL PROFILE AT THE SAME LOCATION AS THE TWO PREVIOUS PHOTOGRAPHS

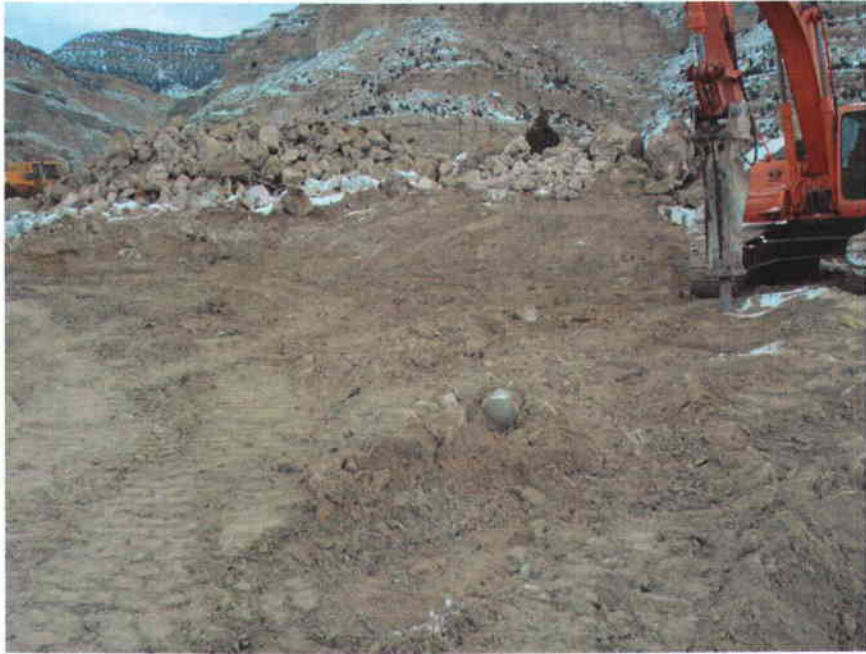
BOULDER REMOVAL SOUTH OF LOADOUT STATION LOOKING NORTH

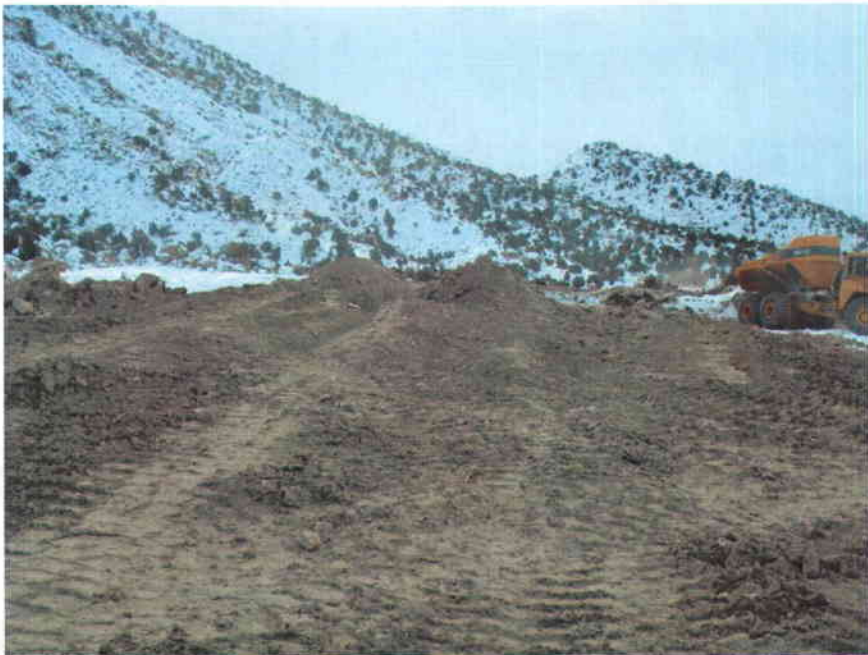
EMPLOYEE PARKING AREA LOOKING SOUTH

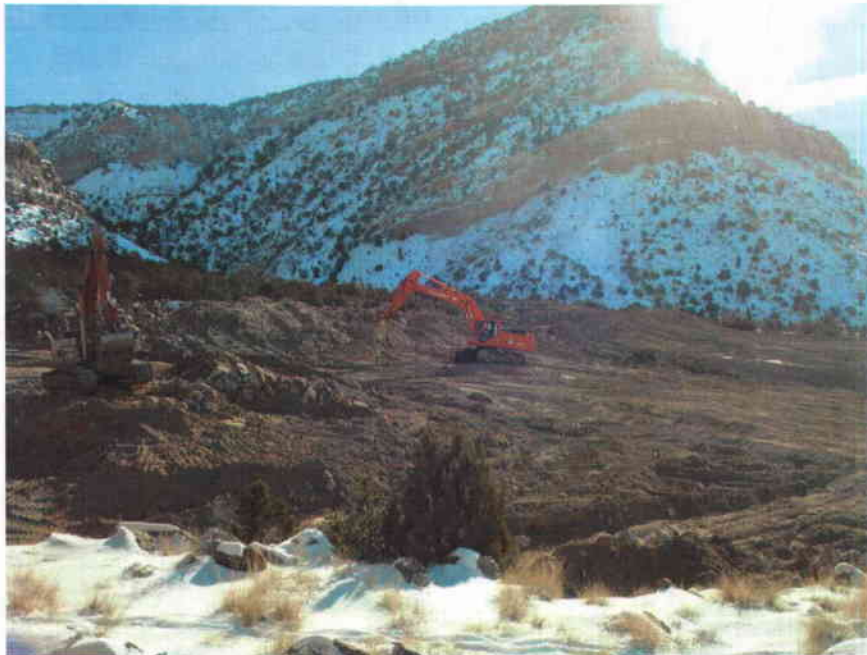
TOPSOIL REMOVAL FROM EMPLOYEE PARKING AREA

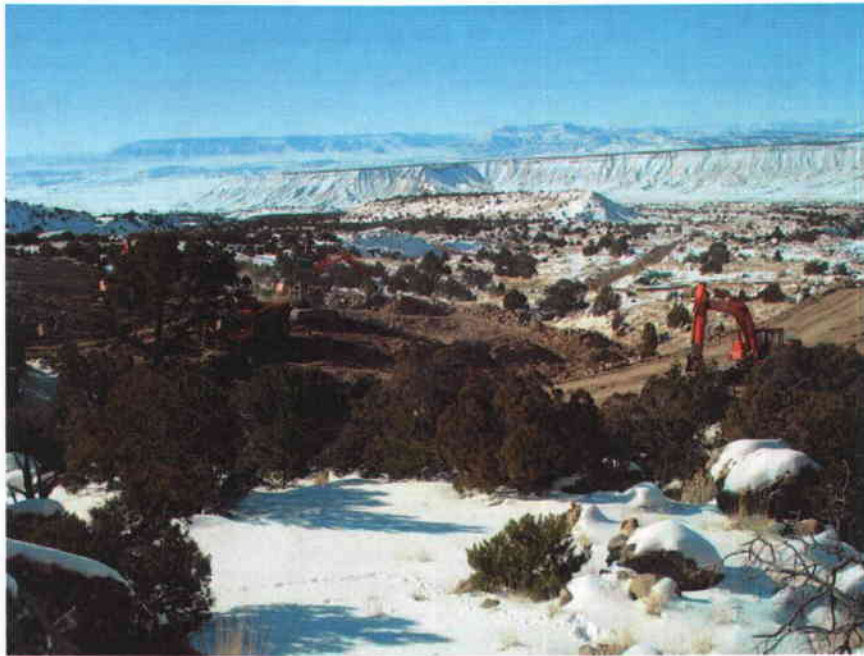
LOOKING SOUTHWEST OVER PROJECT AREA

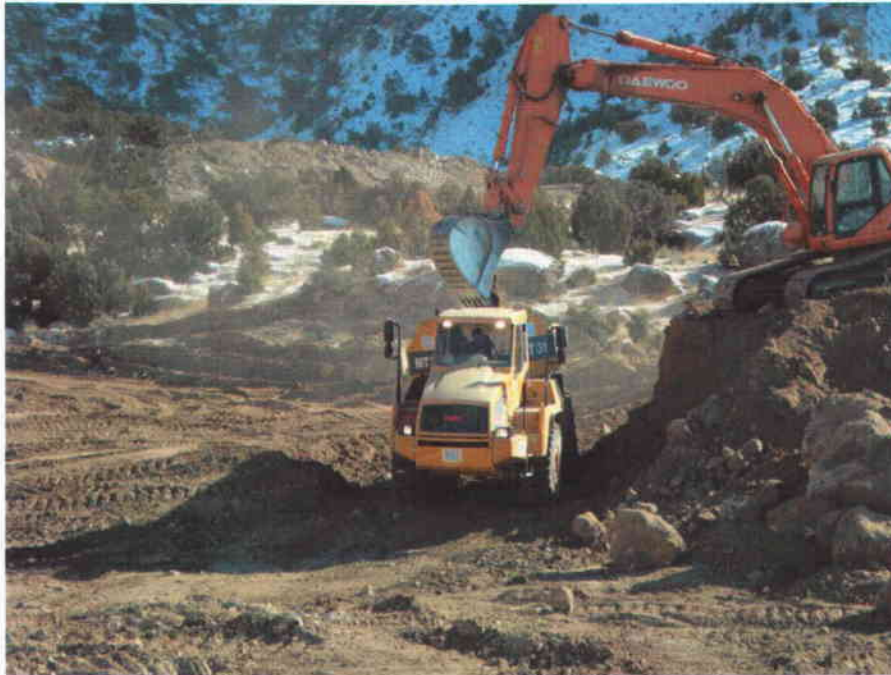
TOPSOIL REMOVAL FROM OFFICE AREA

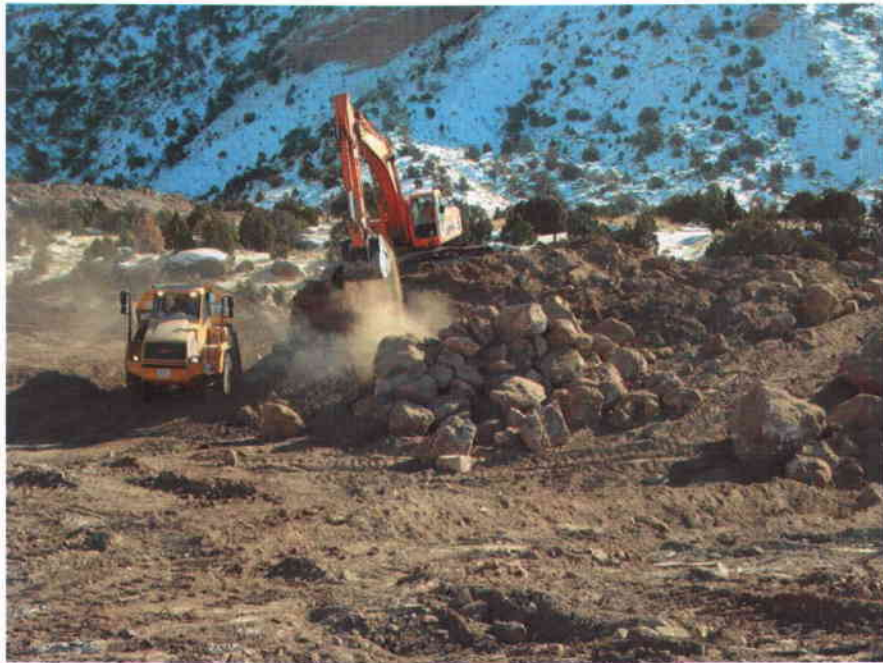
BOULDERS BEING SEPARATED FROM TOPSOIL MATERIAL

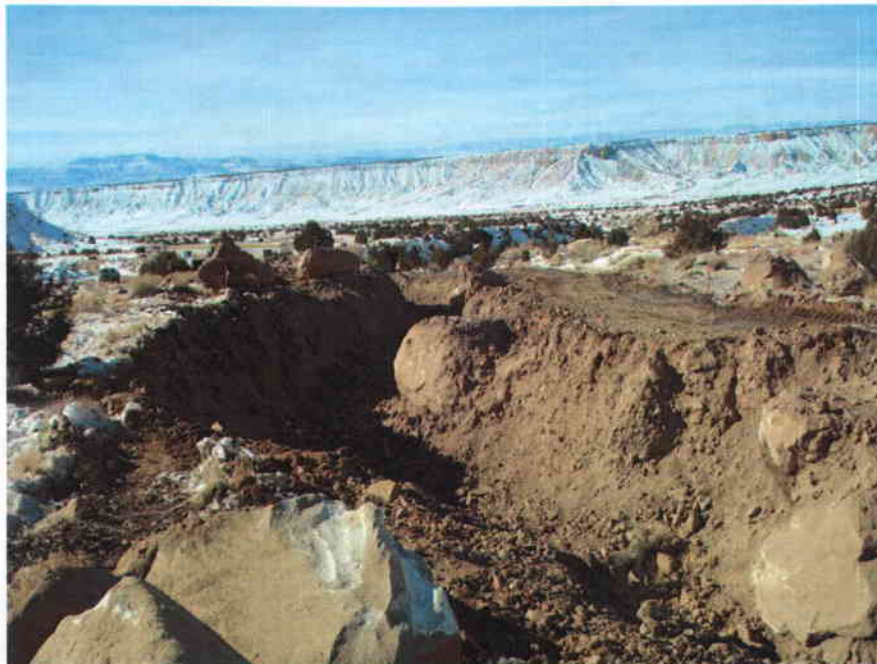
LOWER PORTAL ACCESS ROAD GRADE

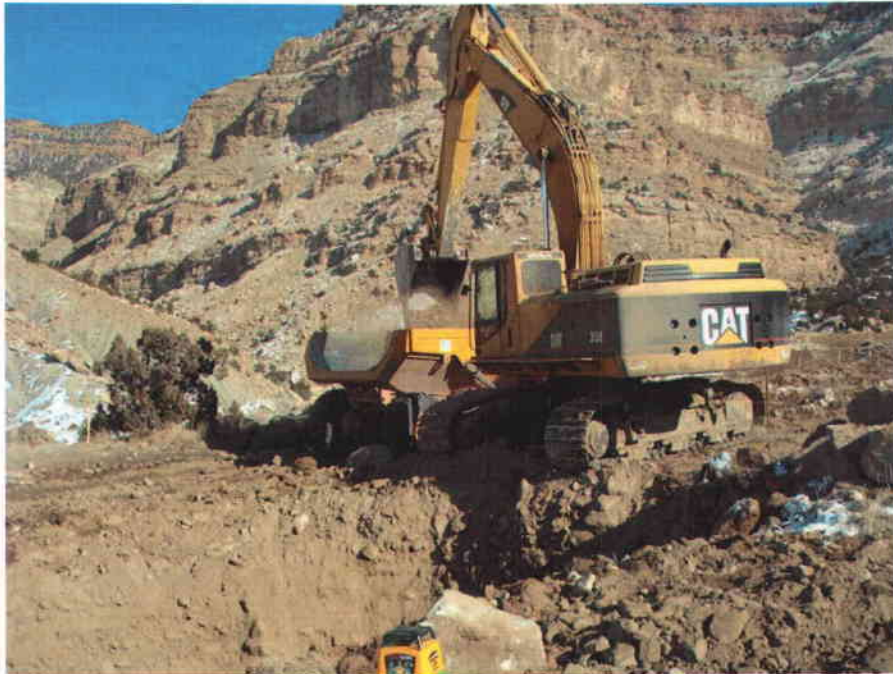
FILL MATERIAL BEING REMOVED FROM PORTAL ACCESS ROAD

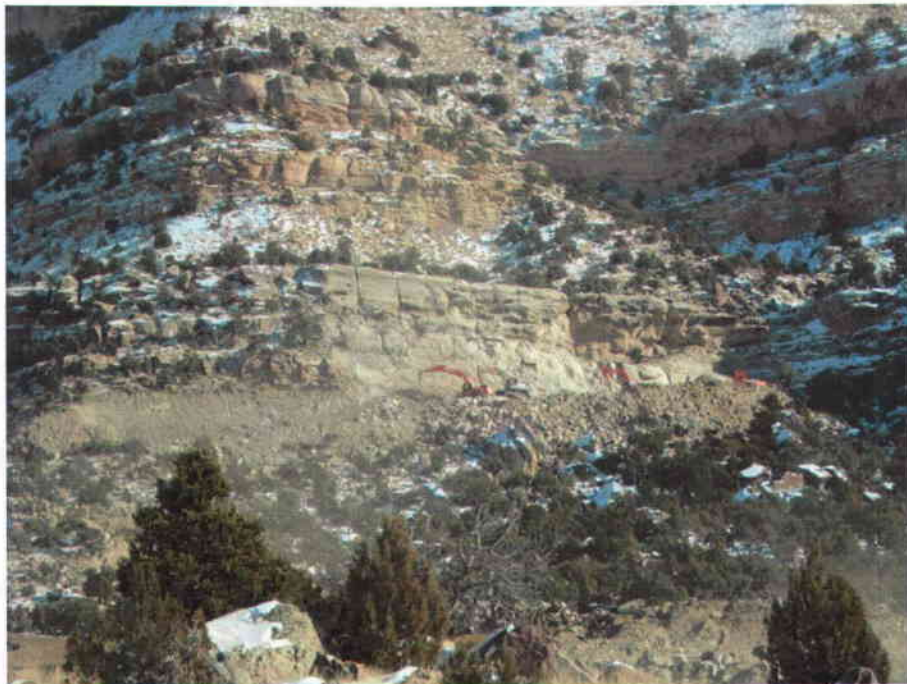
HYDRAULIC BACKHOES WORKING ON PORTAL AREA

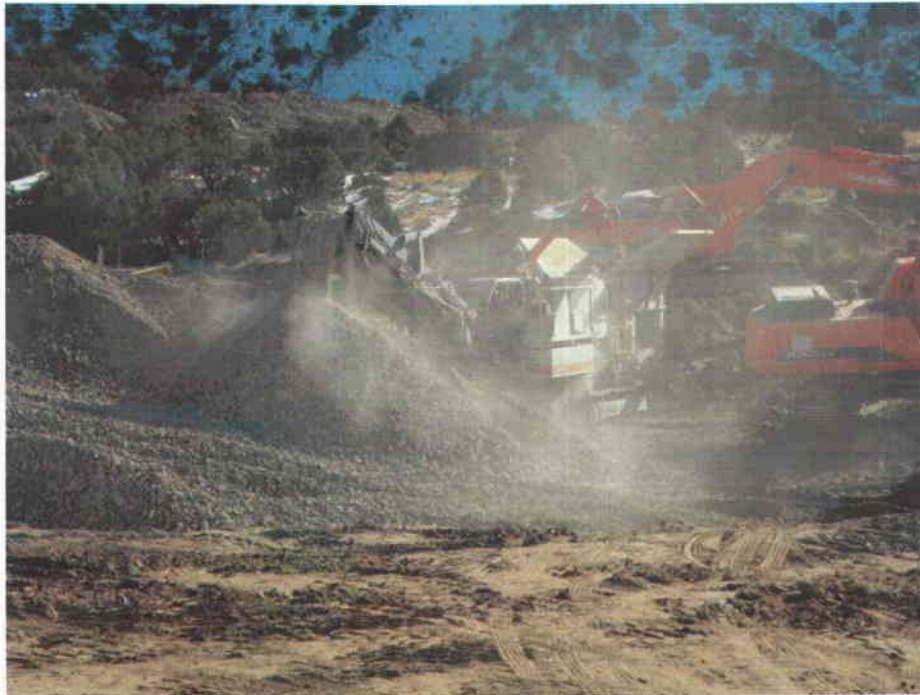
BOULDERS BEING CRUSHED INTO GRAVEL

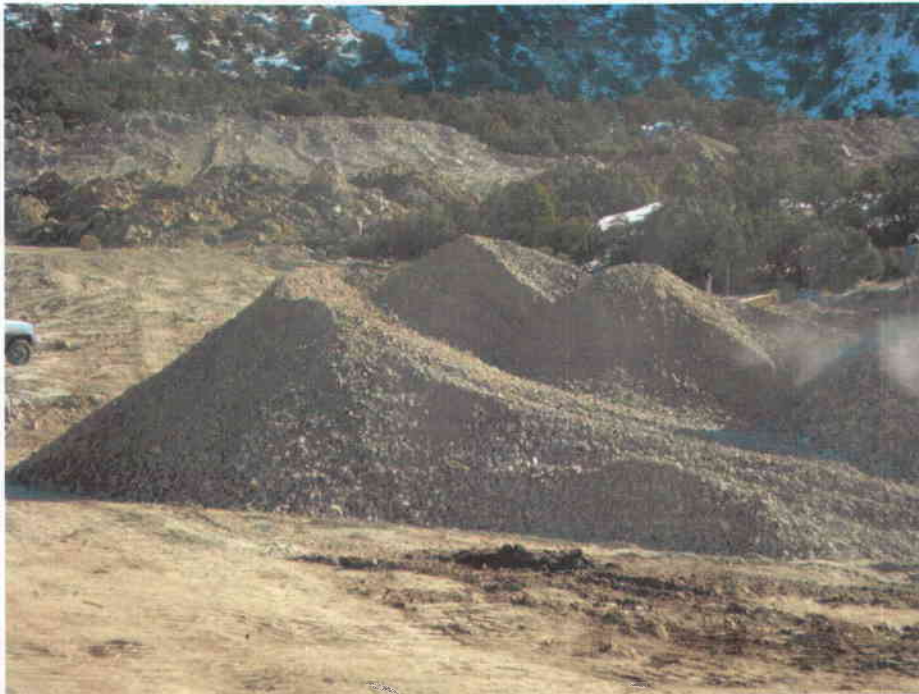
CRUSHED GRAVEL PILE

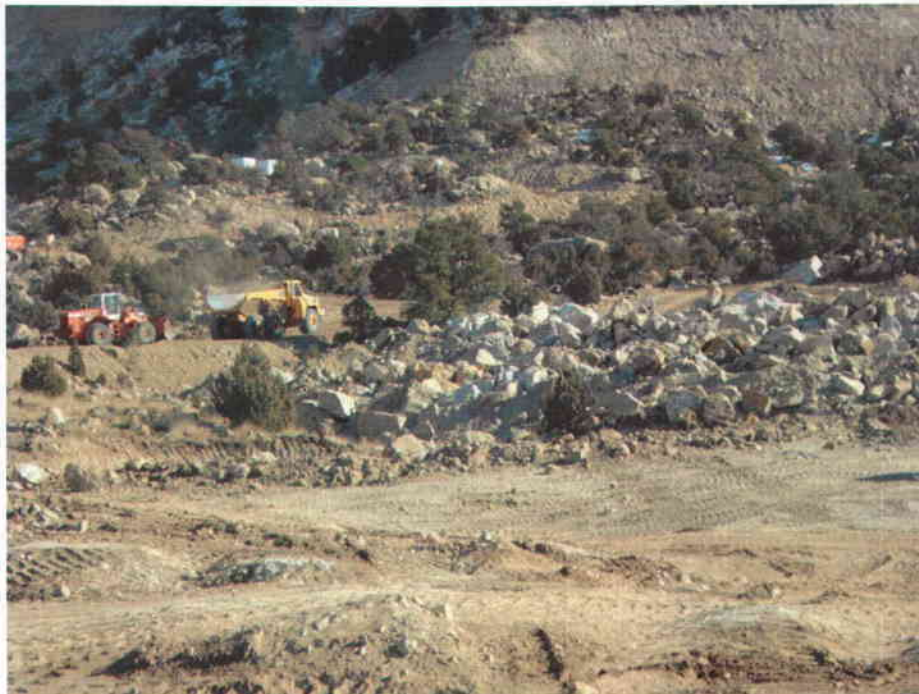
BOULDERS BEING STOCKPILED FOR CRUSHING

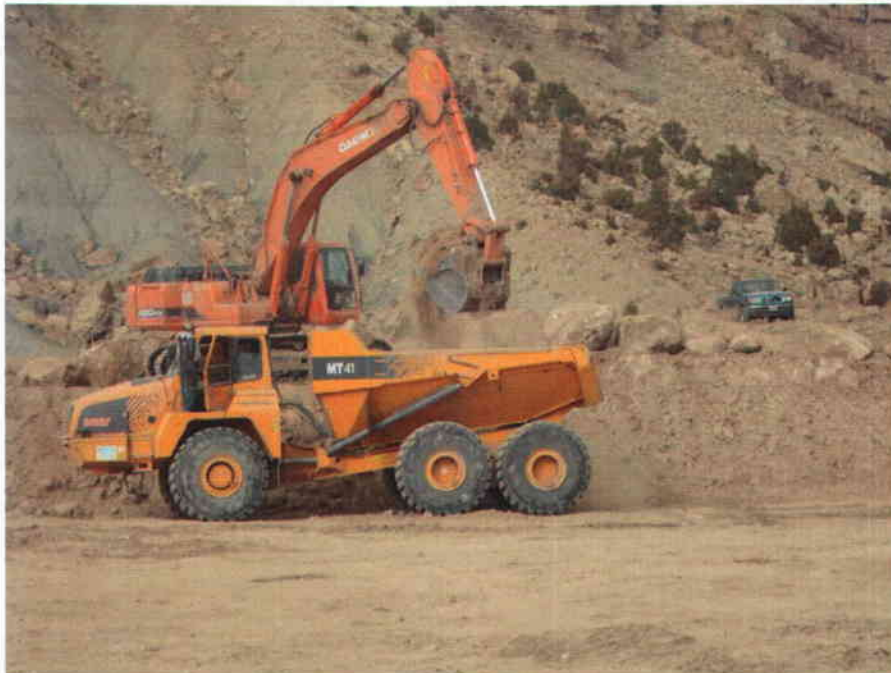
PARKING LOT MATERIAL REMOVAL

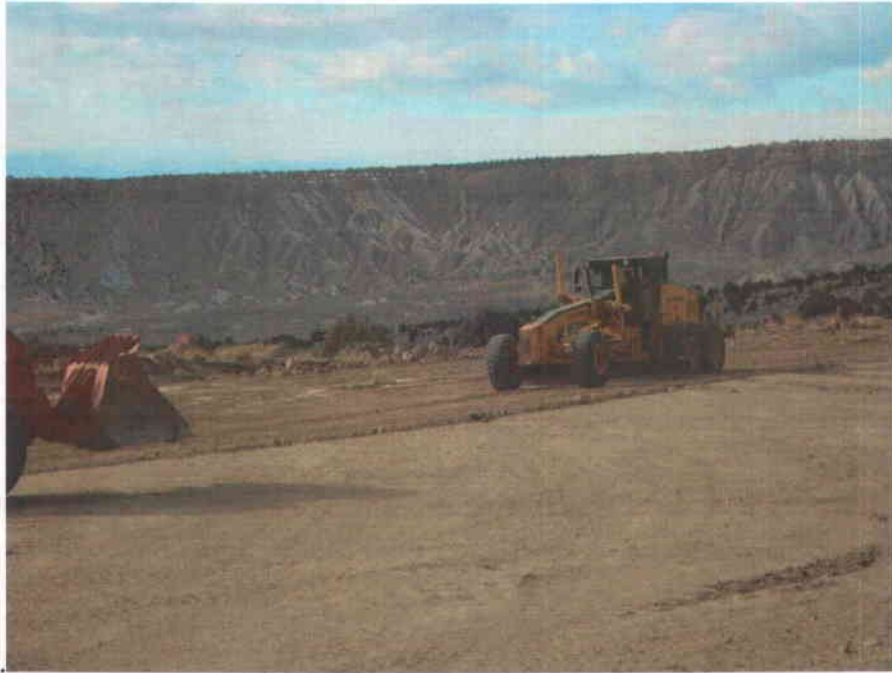
FINAL GRADING WEST END OF EMPLOYEE PARKING AREA

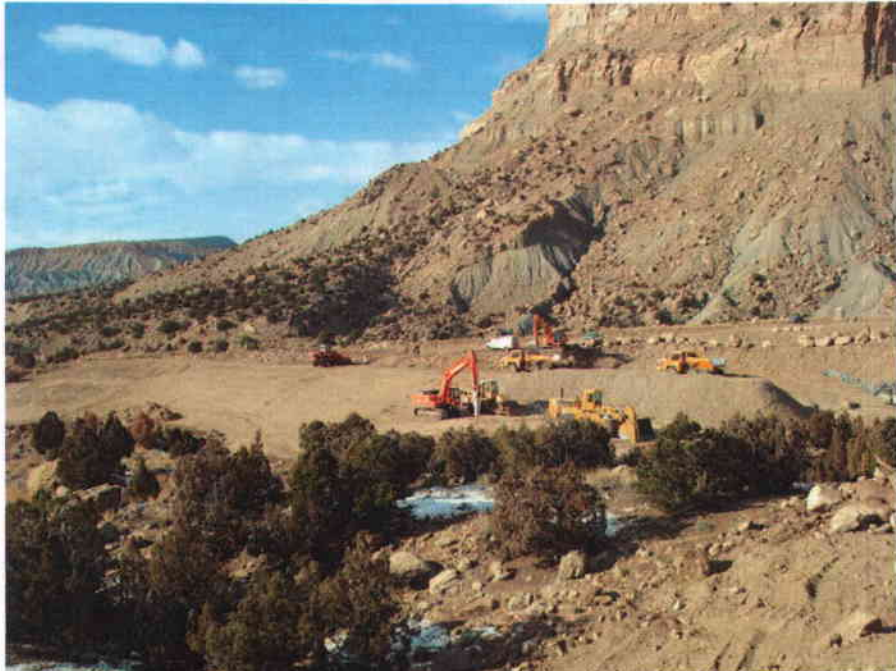
EMPLOYEE PARKING LOOKING NORTH WITH CRUSHED GRAVEL PILE

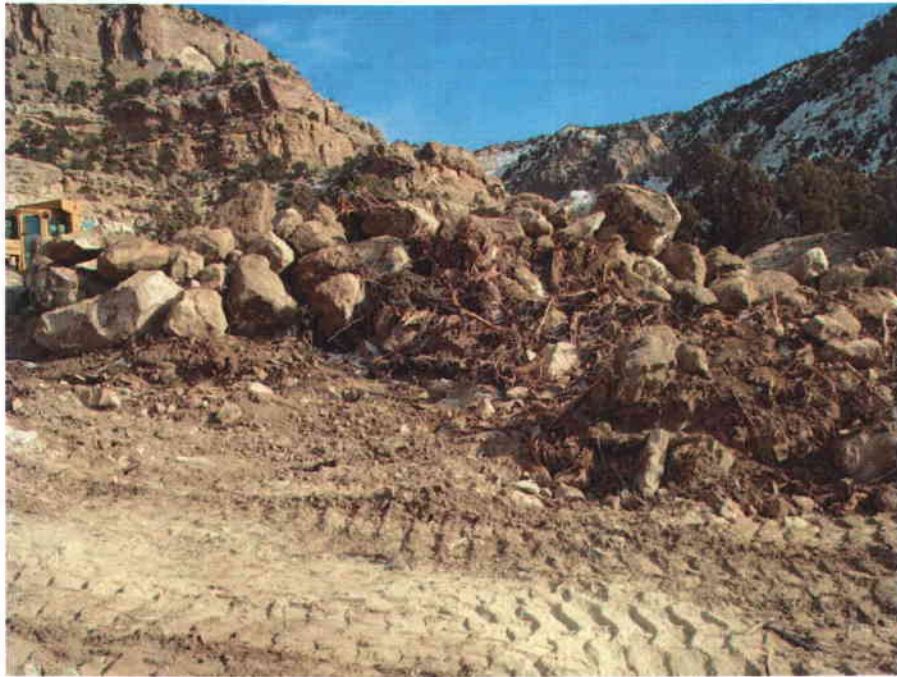
BOULDER REMOVAL FROM STACKING TUBE AREA LOOKING EAST

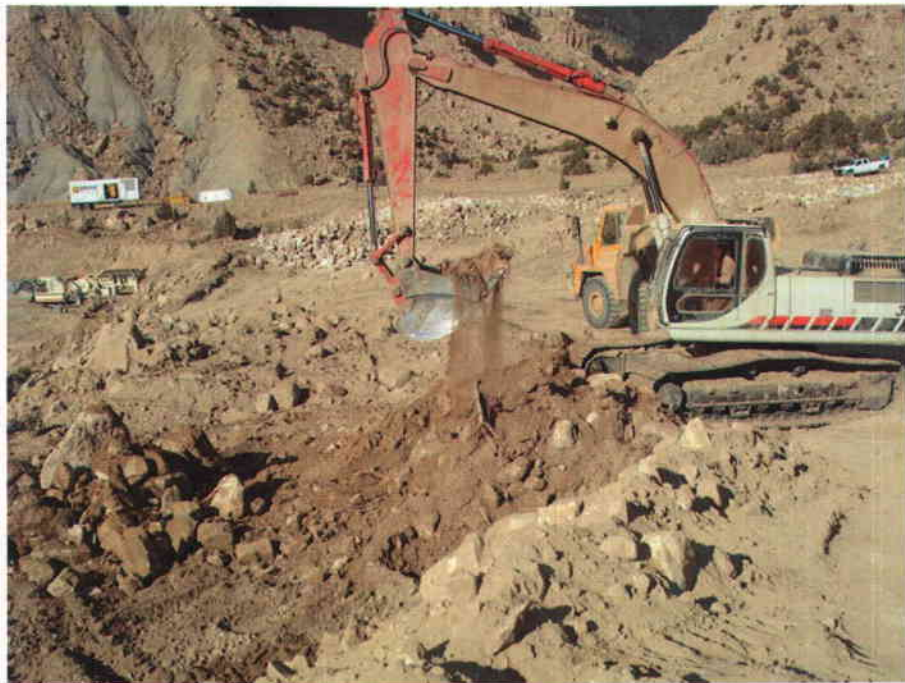
TOPSOIL REMOVAL FROM STACKING TUBE AREA LOOKING NORTH

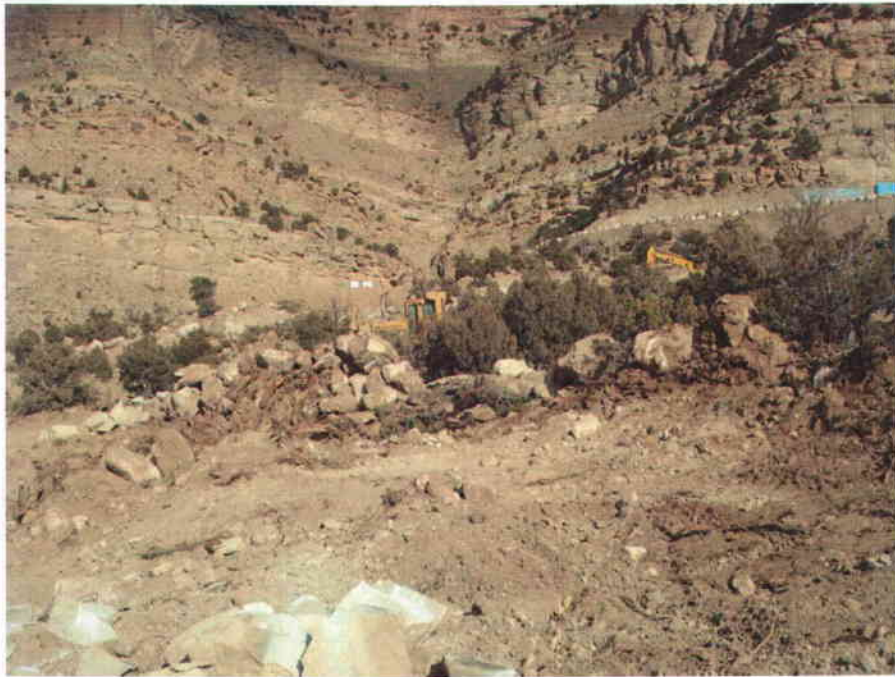
STACKING TUBE AREA LOOKING EAST TOWARDS PORTALS

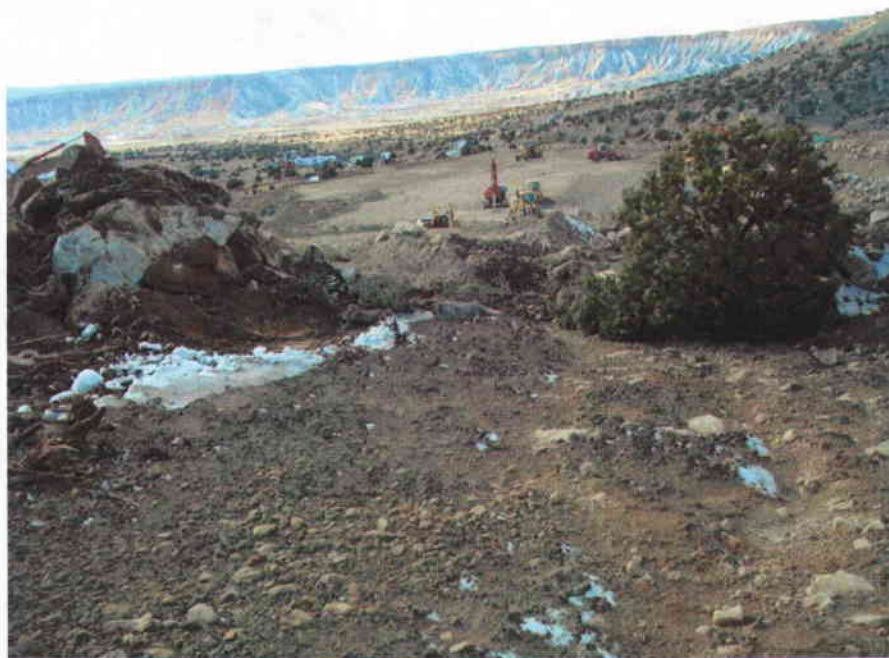
EAST OF STACKING TUBE LOOKING WEST

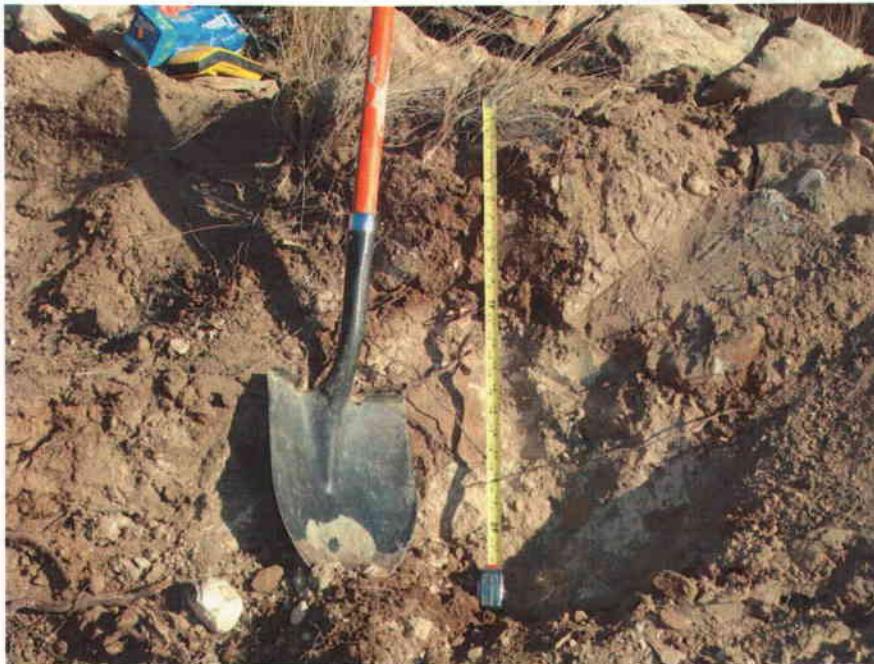
TOPSOIL PROFILE BY STACKING TUBE AREA

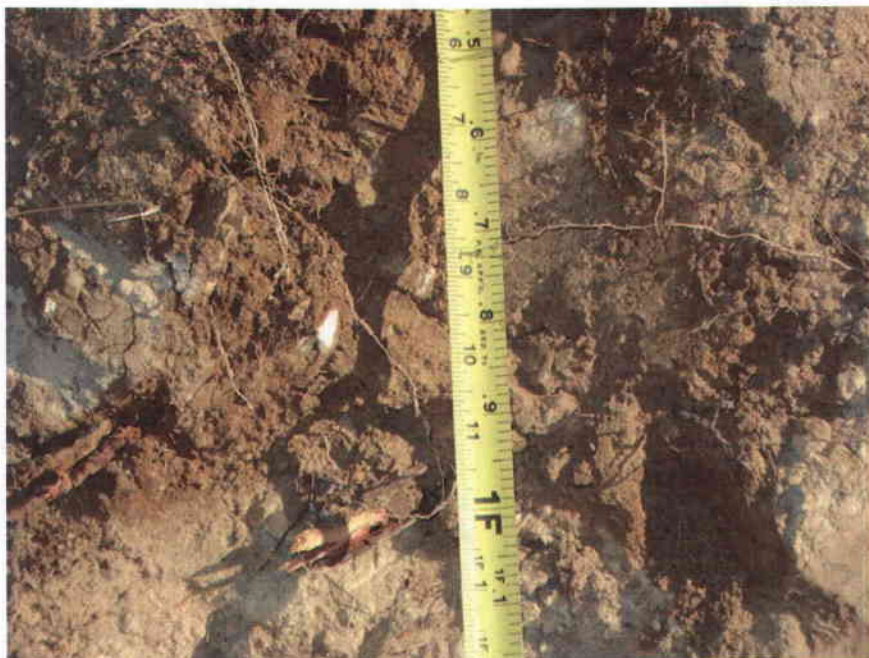
CLOSE-UP OF TOPSOIL PROFILE

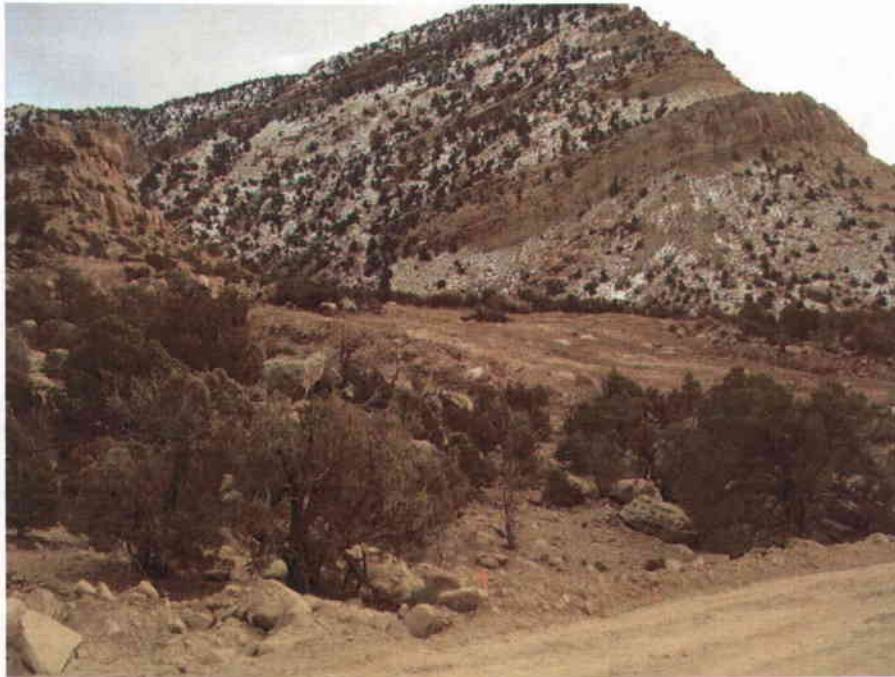
**LOOKING SOUTHEAST FROM SILO AREA, TOPSOIL IS BEING
COLLECTED**

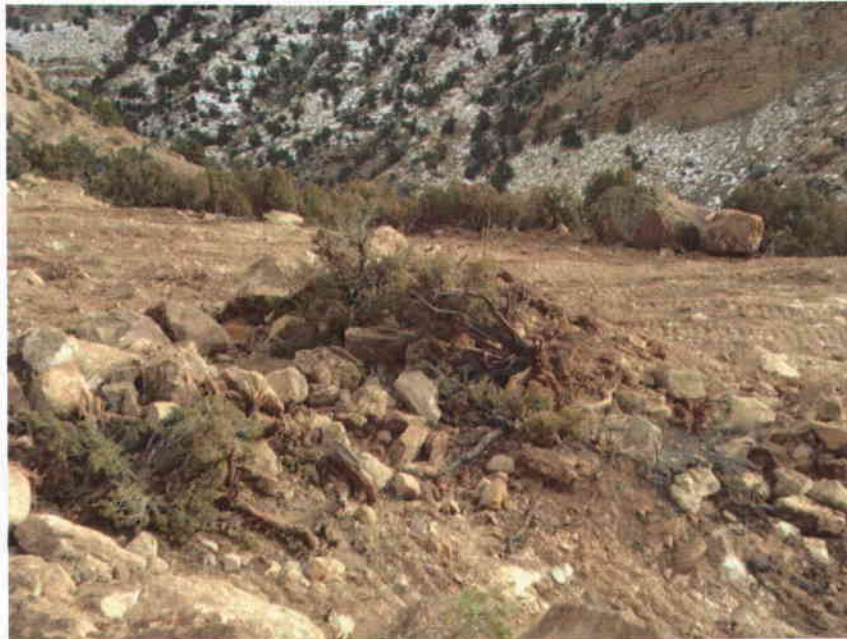
COLLECTING BOULDERS AND VEGETATION

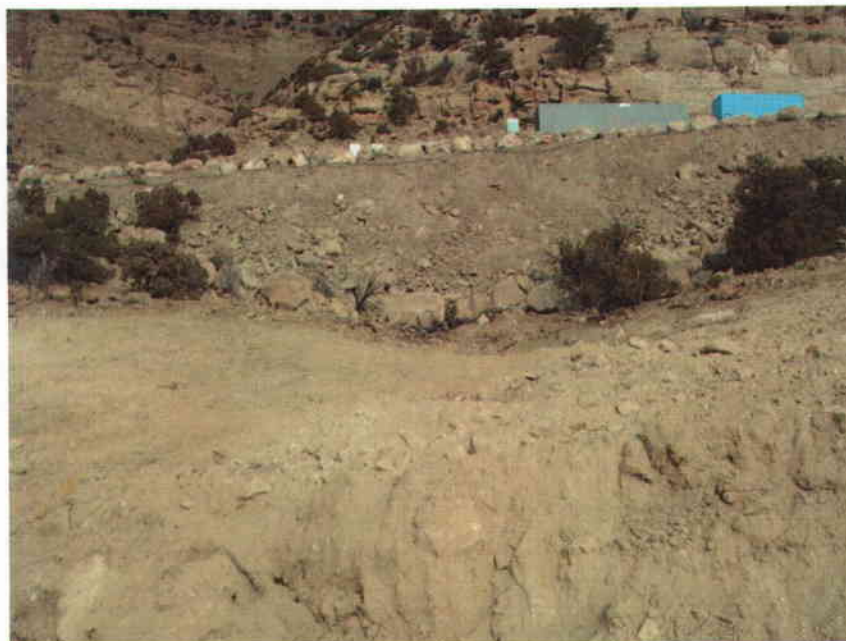
LOOKING NORTHEAST FROM SILO AREA, TOPSOIL HAS BEEN REMOVED

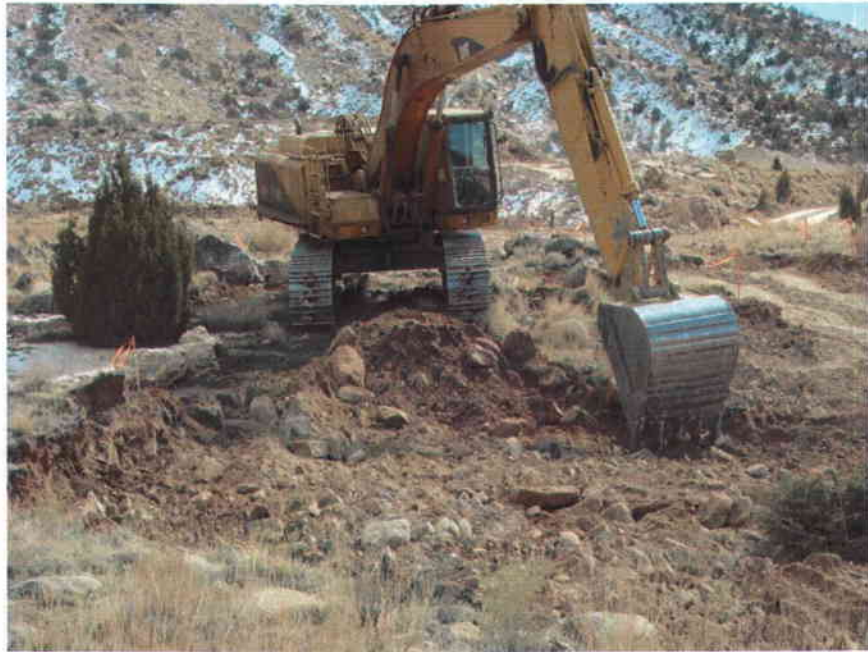
**COLLECTING TOPSOIL AT SMALL STORMWATER RETENTION POND
(SRP)**

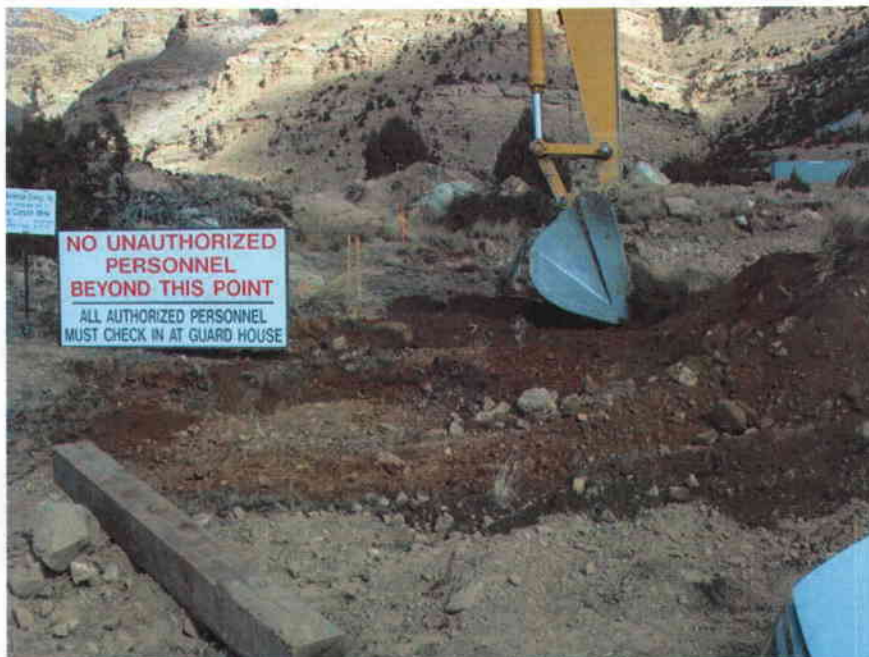
COLLECTING TOPSOIL AT SMALL SRP

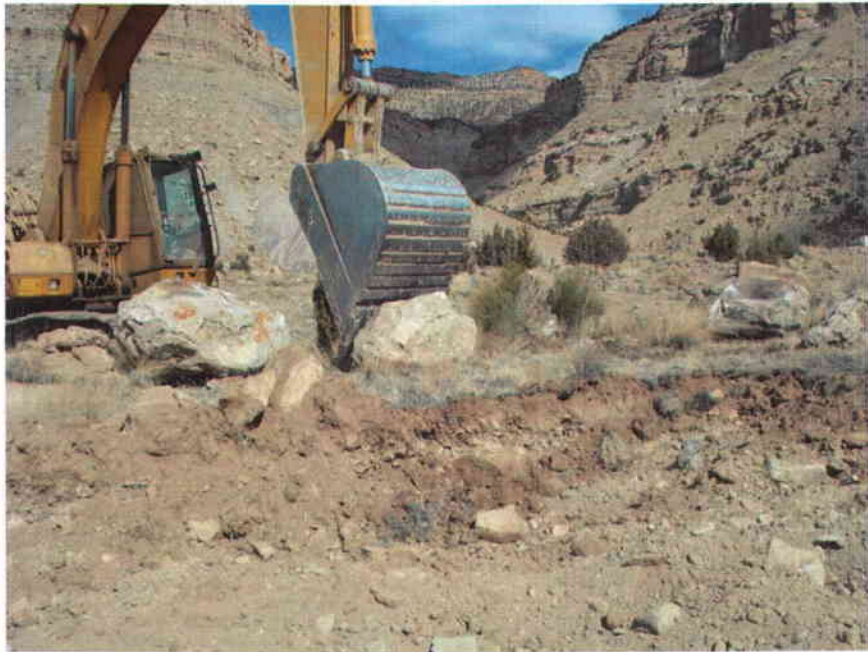
REMOVING BOULDER FROM SMALL SRP

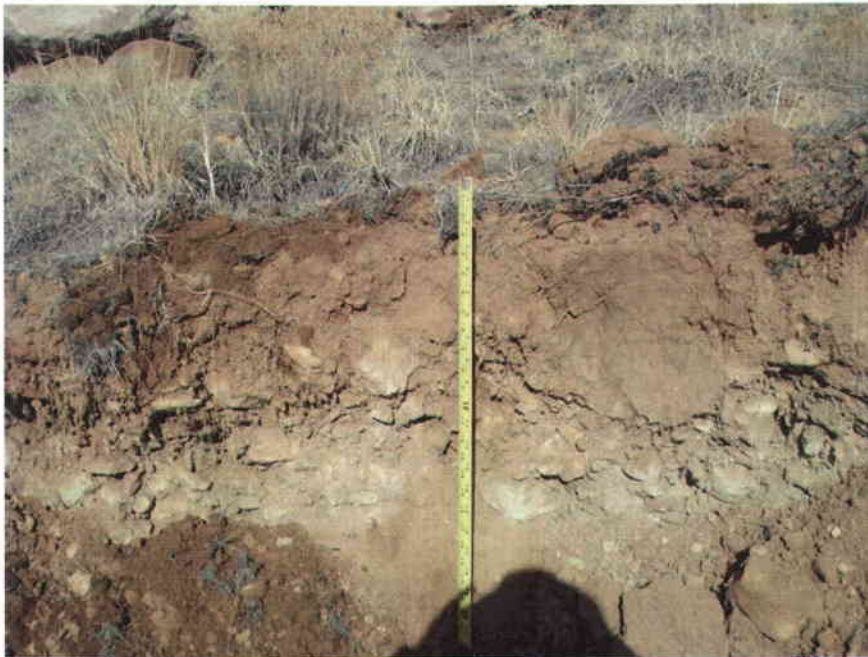
NORTHEAST SOIL PROFILE

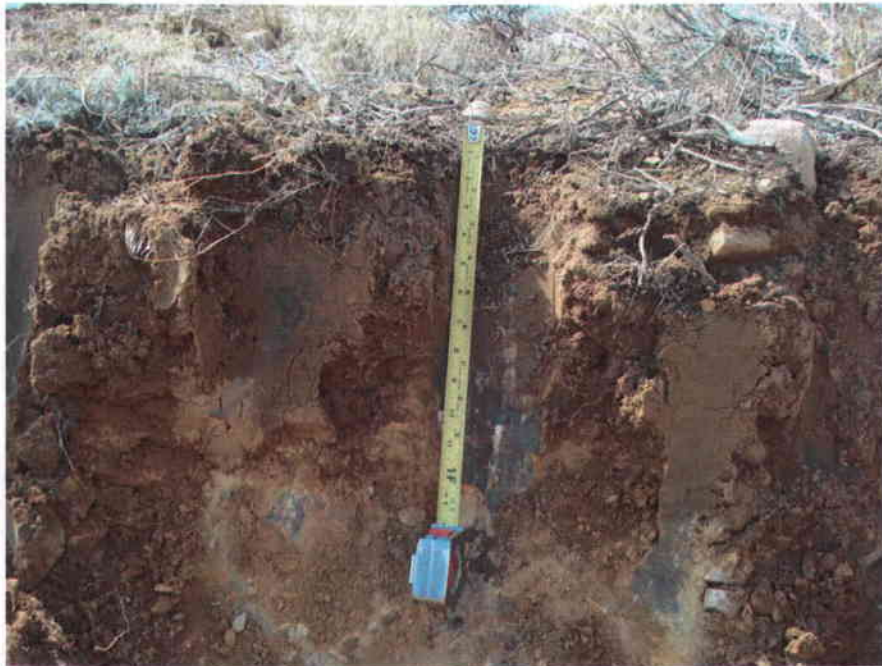
SOUTHEAST SOIL PROFILE

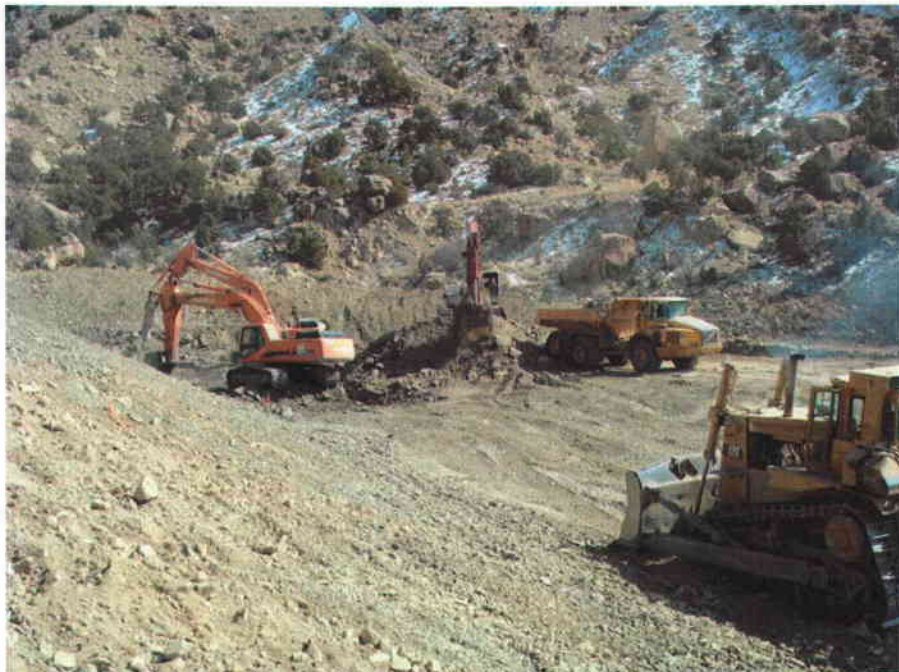
**REMOVE REMAINING MATERIAL FROM LARGE STORMWATER
RETENTION POND (SRP)**
